Manhole Inspection Summary

Manhole # S45II_014MH

Insp Date: **4/30/08 10:39 AM**

Location Address: **Oliver St**

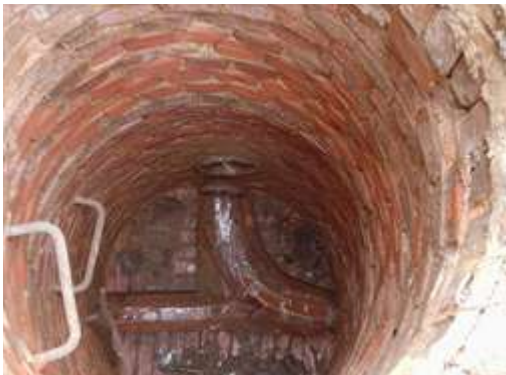
Defect 2

☒ **Leaks**

Frame Leaks

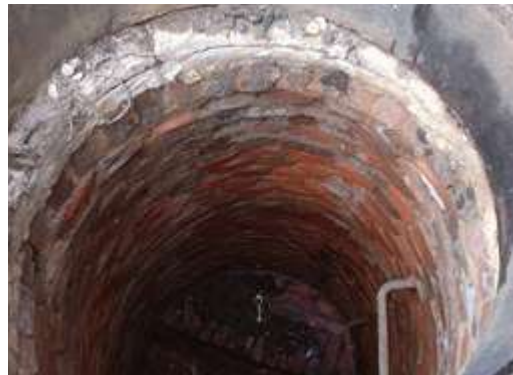
Defect 1

Infiltration: ☐ None ☒ **Joint** ☐ Cracks ☐ Mortar ☐ Roots ☐ Wall

Infiltration: ☐ None ☐ Joint ☐ Cracks ☐ Mortar ☐ Roots ☒ **Wall**

Infiltration

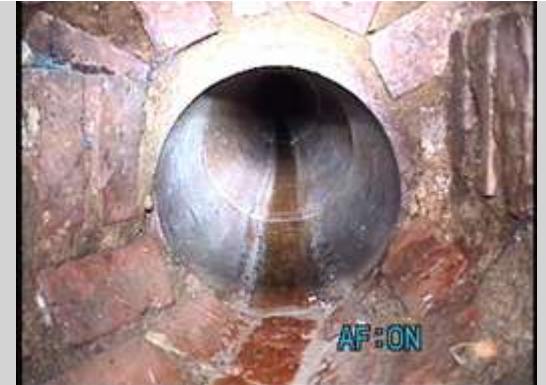
12 O'Clock Outflow

8 in. Circular Gravity Sewer
Pipe Out @ 12 O'Clock

Pipe Height: **8.4** (in.) Rod and Bar (Angled)
Pipe Material: **Clay** ☐ Pipe Lined
Invert Depth: **8.90** (ft.) Flow Characteristics: **Fast**
Deposits: ☒ None ☐ Mud ☐ Sludge ☐ Debris ☐ Grease
Silt Depth: (in.) Deposits Extent:
Infiltration: **None** Pipe Seal Cond: **Sound**

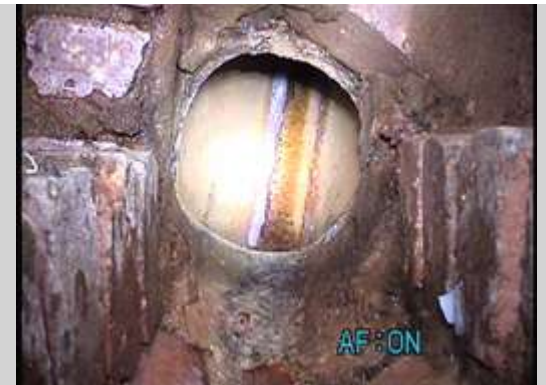
6 O'Clock Inflow

6 in. Circular Gravity Sewer
Pipe In @ 6 O'Clock

Pipe Height: **6** (in.) Rod and Bar (Angled)
Pipe Material: **Clay** ☐ Pipe Lined
Invert Depth: **8.30** (ft.) Flow Characteristics: **None**
Deposits: ☒ None ☐ Mud ☐ Sludge ☐ Debris ☐ Grease
Silt Depth: (in.) Deposits Extent:
Infiltration: **None** Pipe Seal Cond: **Sound**

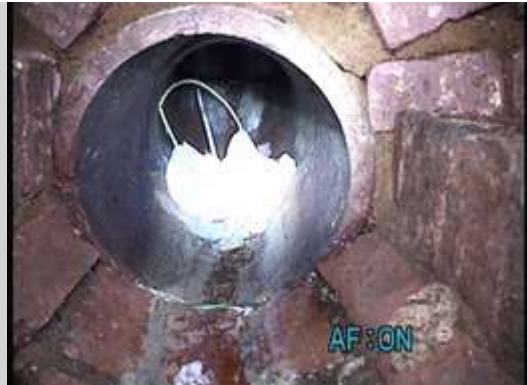
9 O'Clock Inflow

8 in. Circular Gravity Sewer

Pipe In @ 9 O'Clock

Pipe Height: **8.4** (in.) Rod and Bar (Angled)

Infiltration: **None** Pipe Seal Cond: **Sound**

Drop: Inside	Rod and Bar
Angled: Yes	Reading: 7.50 (ft.)
	Inv Depth: 8.50 (ft.)
Drop Condition: Open
